# Manhole Inspection Summary

Manhole # S49A\_\_003MH

Insp Date: **5/7/08 11:37 AM**

**Location** Address: **237 n lakewood ave**

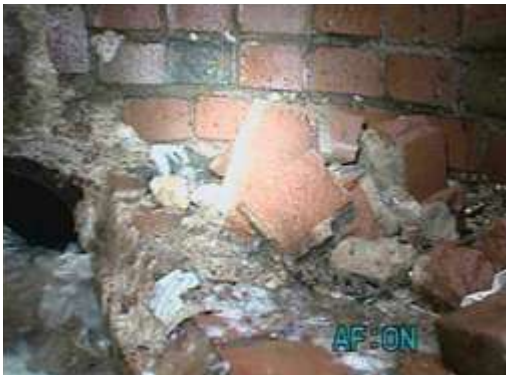
Defect 4

Condition: ☐ Sound ☐ Cracked ☐ Root Intrusion ☐ Deteriorated ☐ Leaks ☒ **Debris**

bench debris

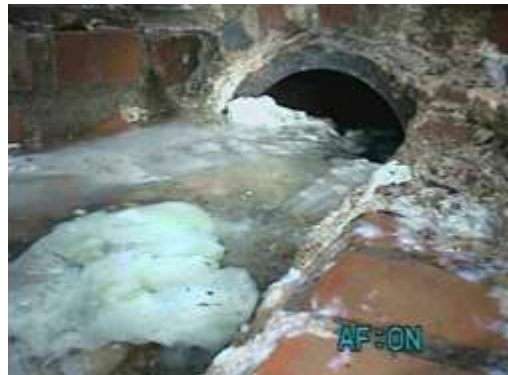
Defect 3

Condition: ☐ Sound ☐ Cracked ☐ Root Intrusion ☐ Deteriorated ☐ Leaks ☒ **Debris**

channel debris

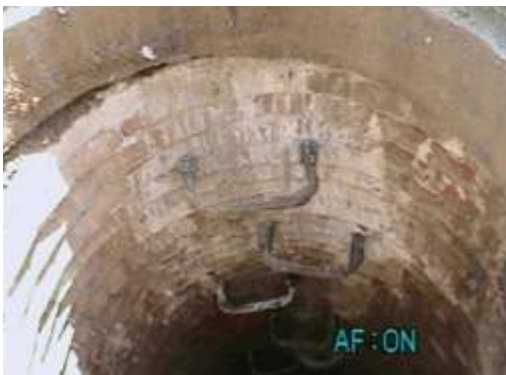
Defect 2

Condition: ☐ Sound ☐ Cracked ☐ Root Intrusion ☐ Loose Brick ☒ **Deteriorated**

Count: **5** Missing: **0** ☒ **Corroded**

steps corroded, corbel deteriorated

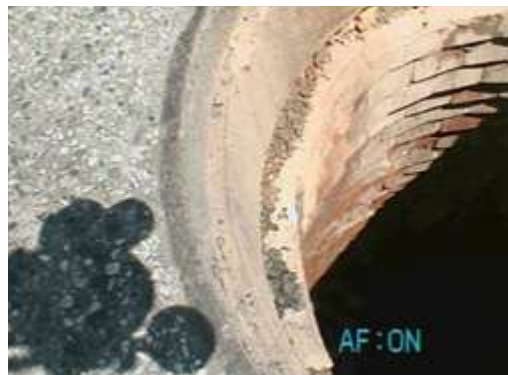
Defect 1

Offset: **2** (in.)

offset

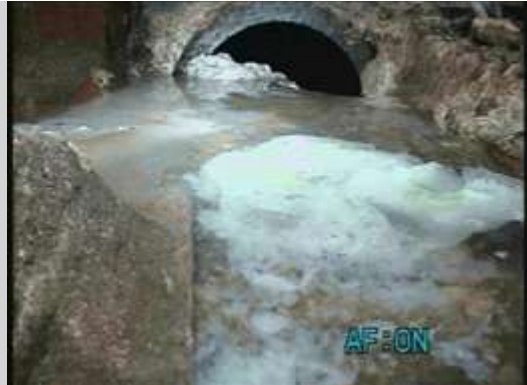
12 O'Clock Outflow

Deposits: ☐ None ☐ Mud ☒ Gravy ☒ Debris ☐ Grease

Silt Depth: **5** (in.) Deposits Extent: **Heavy**

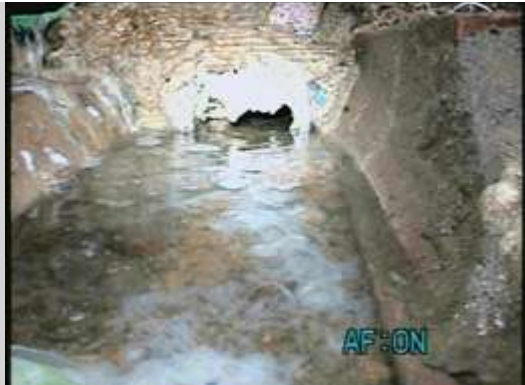
6 O'Clock Inflow

Deposits: ☐ None ☐ Mud ☒ Sludge ☒ Debris ☐ Grease

Silt Depth: **7** (in.) Deposits Extent: **Heavy**

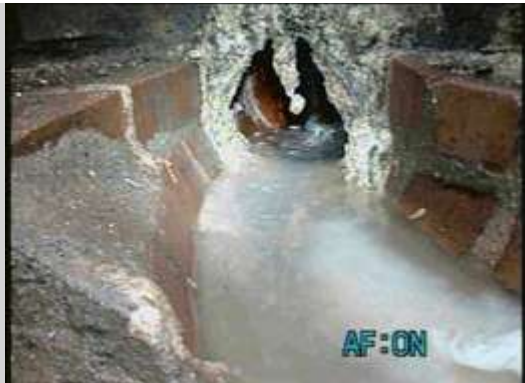
9 O'Clock Inflow

Deposits: ☐ None ☐ Mud ☐ Sludge ☒ Debris ☐ Grease

Silt Depth: **1** (in.) Deposits Extent: **Light**
